Introduction and Contract History – Yellowstone National Park & Yellowstone Park Service Stations

LOCATIONS:

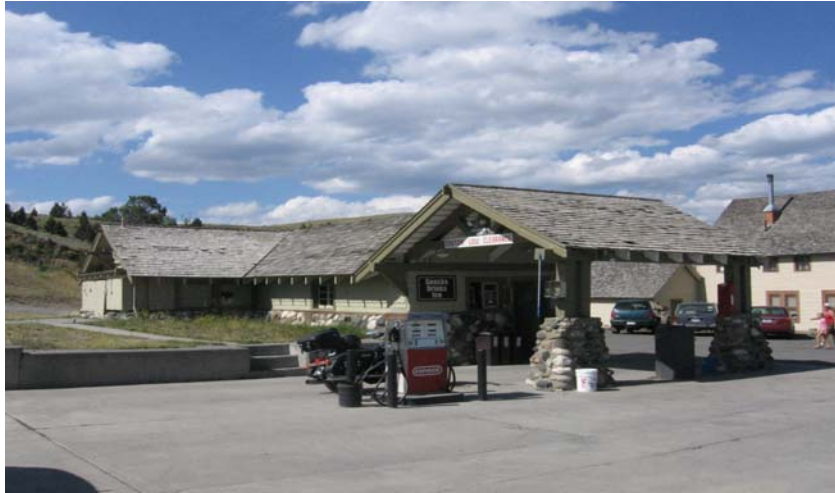
Mammoth – This service station was constructed in 1940.

- The existing equipment shed at the west end of the building is in very poor condition. It should be removed and replaced. This component sequence addresses demolition and a new concrete slab.

- The existing concrete floor slab in Sales 101 is cracked and has settled. The cracks should be repaired / stabilized and a leveling topping applied, then painted.

- The floor joists beneath Storage 103 are unstable and out of level. The existing wood flooring should be removed, damaged joists replaced and the floor system stabilized. Plywood subfloor should be installed.

- The double barge rafters on the west gable of the fueling island canopy are damaged and should be replaced.
- The beams and columns are in need of scraping, sanding and re-finishing. The presence of lead based paint on the columns and beams should be assumed.

- The exposed deck and rafters are due for painting. This Component Sequence provides the roof structure for the new equipment shed including joists and decking. Observed some movement in canopy structure and noted that seismic restraint was not present. Slat type diaphragm does not adequately tie canopy to main building structure, therefore, the canopy may move independent of the main structure when experiencing a seismic event. In its present condition, the canopy is at risk of becoming unstable and collapsing during a seismic event. Further seismic investigation by a qualified structural engineer is recommended.

- The wood shingle siding and the 2x above the stone veneer are due for replacement in kind.
- All stone veneer all around the building and at the canopy pillars is in need if a major rehabilitation. The mortar is in poor condition and many stones are missing.

- The concrete caps at the top of the low stone pillars at the fueling island canopy are deteriorating and should be replaced. The Component Sequence provides the wall structure and siding for new equipment shed.

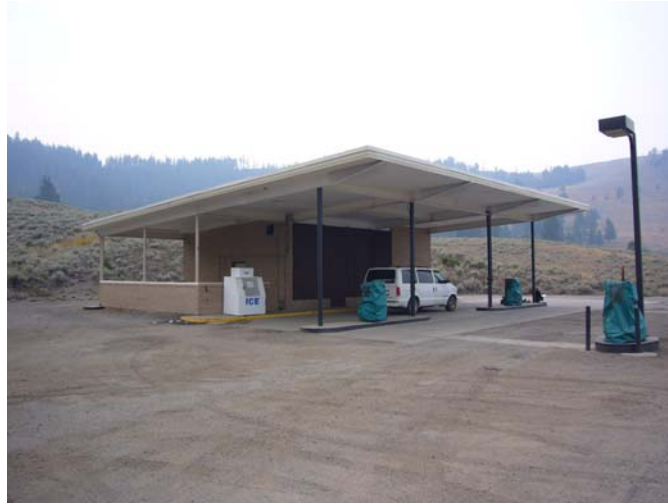
Tower Falls Junction - This station was built in 1962 during the Mission 66 Era and is out of character with the rustic aesthetics of the Roosevelt area.

Facility Construction/Maintenance – The station is cement block construction. Underground storage tanks have been replaced at this station. Accessible public restrooms are available.

- Exterior CMU mortar joints are deteriorated and require re-pointing. There are numerous cracks, broken or missing concrete masonry units that require replacement.
- Metal bases for fueling islands are due for painting.
- Metal columns for fueling island canopy are due for painting.
- Metal roof beams for fueling island canopy are due for painting.
- Exterior plywood soffits are due for painting.
- Exterior wood overhead door is deteriorating and due for replacement.
- Exterior hollow metal doors and frames are due for painting.
- Interior wood door is due for painting.
- Exterior metal gutters and downspouts are damaged and due for replacement.
- Concrete floors in Rooms 101 (sales) and 102 (office) are due for painting.

- Ceiling in Room 101 (sales) exhibits un-repaired water damage from previous roof leaks. Repair bubbles and deteriorated tape joints in gypsum board and paint.

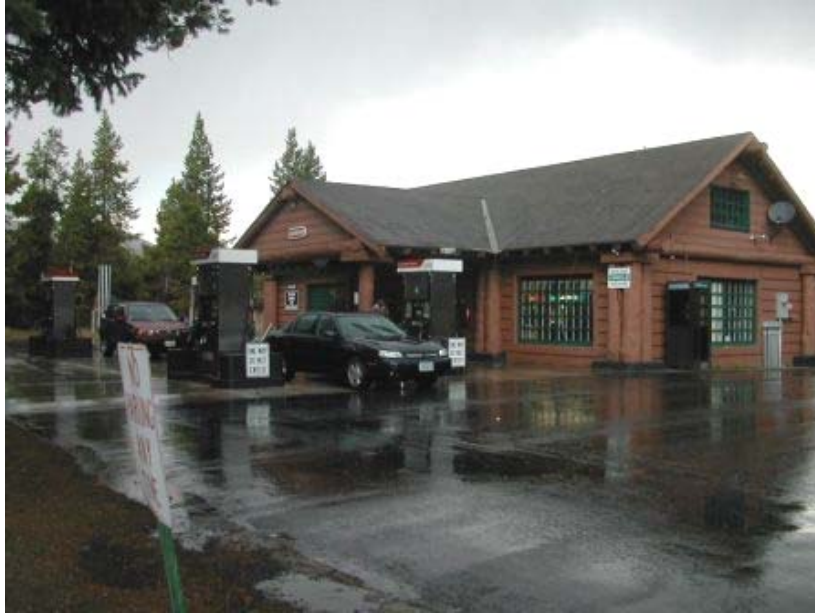
Fishing Bridge

This station and repair garage were built in 1927.

- The log barge rafters in all 4 gables are rotted and should be replaced.
- The end of the log eave and ridge beams in the east and west gables, and the eave beams in the north gable, are rotted and should be replaced.
- The “false” ridge log in the north gable is rotted and should be replaced.
The first row of 2x12 wood decking and the log rafter tails in various locations around the building are rotted and in need of either repair or replacement as follows; replace
- 7 tails at the east eave of the north canopy, repair 10 tails at the west eave of the north canopy, replace 4 tails at the east eave of the south canopy, replace 4 tails at the west eave of the south canopy, repair 6 tails on the south eave, East of the south canopy, repair 5 tails on the south eave west of the south canopy and replace the first row of 2x12 wood decking all around the perimeter of the building.

- No seismic connections were observed between the roof system and the top of concrete walls. Further seismic investigation by a qualified structural engineer is recommended. Separation of connection in truss compression web (diagonal) member. The observed separation seems to indicate that the weight of planking on the bottom chord of the truss exceeds the original truss design load. Further investigation is needed to determine if the truss and truss parts are adequate and if they are adequately connected together. The work for this Deficiency Sequence can be combined with the recommended seismic analysis addressed by a separate Deficiency Sequence.

- The wall shingles in the west, north and east gables are either deteriorated or have been damaged over time and should be replaced.
- The upper exposed surface of the horizontal wall logs at the top of the concrete walls in the east and west gables in beginning to weather. These logs should be repaired and painted.

- The bases of the logs at the southeast corner of the main building are deteriorated and should be restored and painted. This will require high performance consolidants and filters.

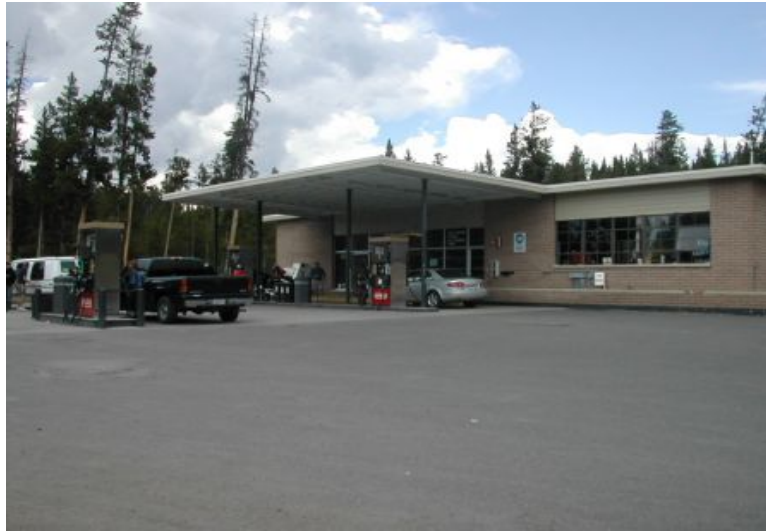
Canyon –

This station was built in 1956.

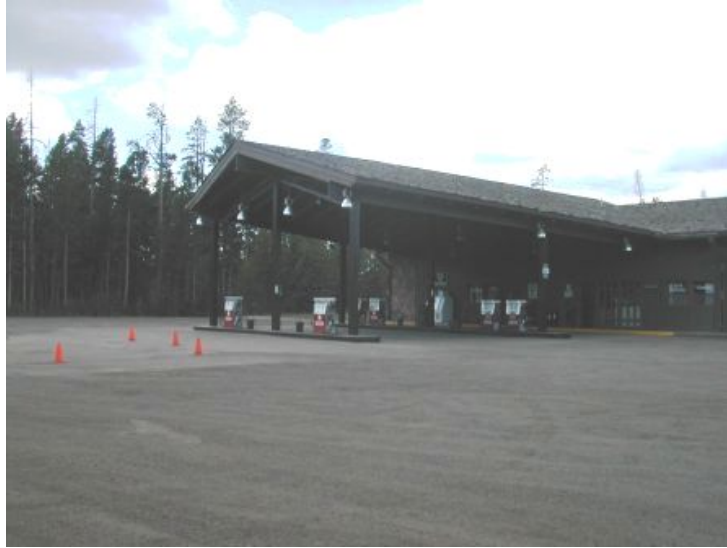
Grant – This service station was constructed in 1970.

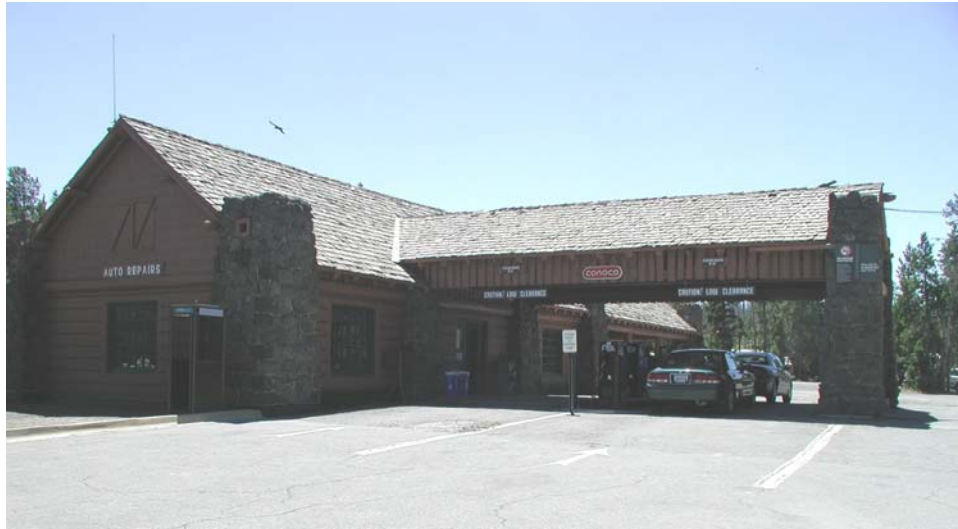
Old Faithful Upper Station – This station is a historic structure constructed in 1940.

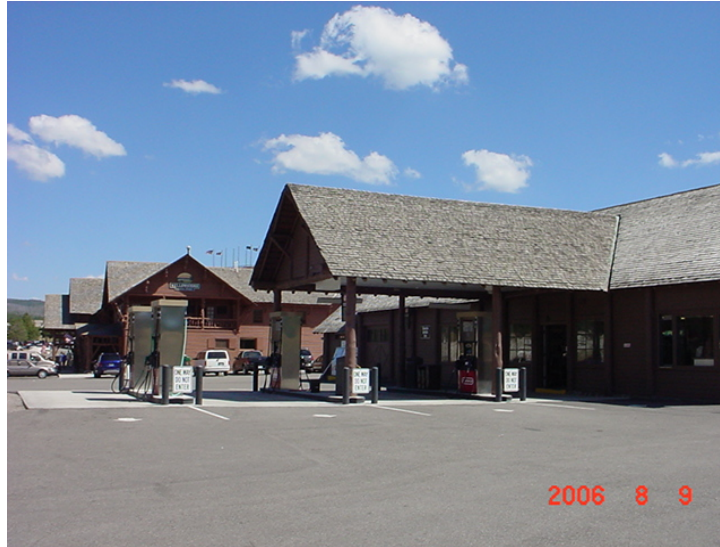
Old Faithful Lower Station – This station is a historic structure constructed in 1927.
